**Technology Evaluation for Environmental Risk
Mitigation Principal Center (TEERM)**

**Hexavalent Chrome Free Coatings for Electronics
Applications**

DRAFT Joint Test Report

September 2012

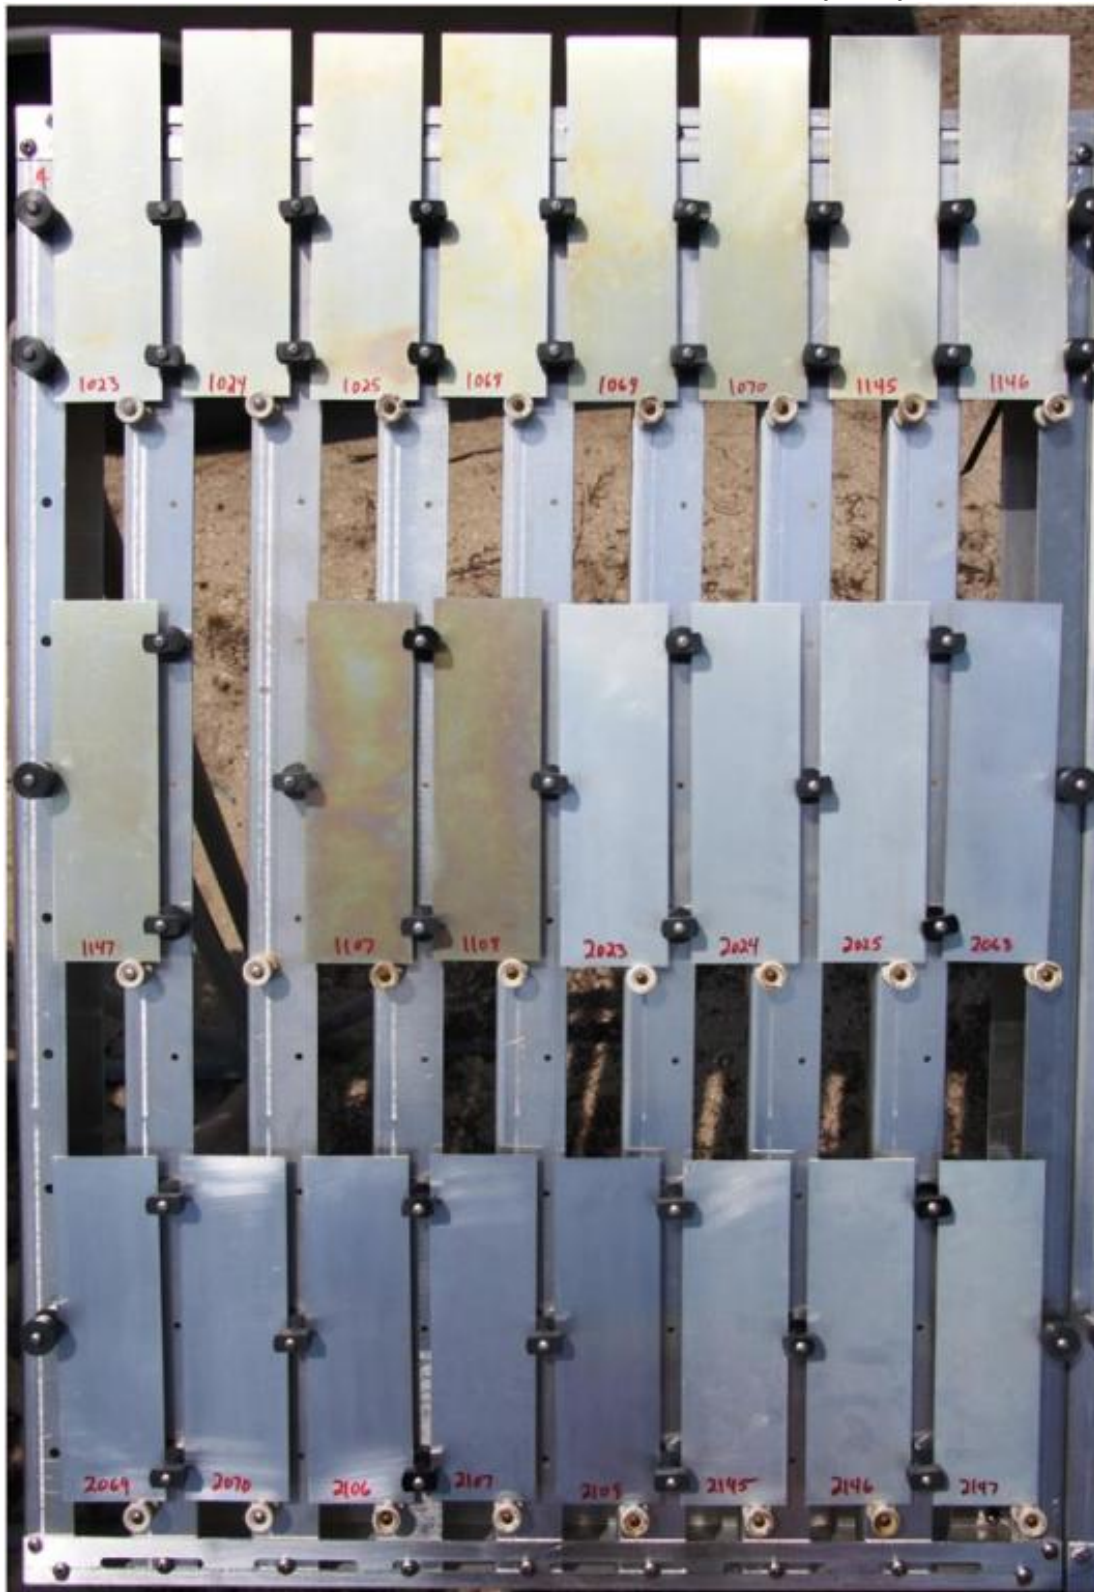
Figure 106 - Beachside Corrosion; Rack 1

Following 5 weeks of atmospheric exposure, all test panels showed signs of pitting through the entire test panel regardless of pretreatment or alloy. Overall the pitting was fairly consistent across all test panels with numerous small pits throughout the test panels.
